# Inspection of a filled hot water storage tank using a robot

SIAPWS Annual Meeting 2019  
Helsinki

# Inspection of hot water storage tank at Studstrup Power Plant

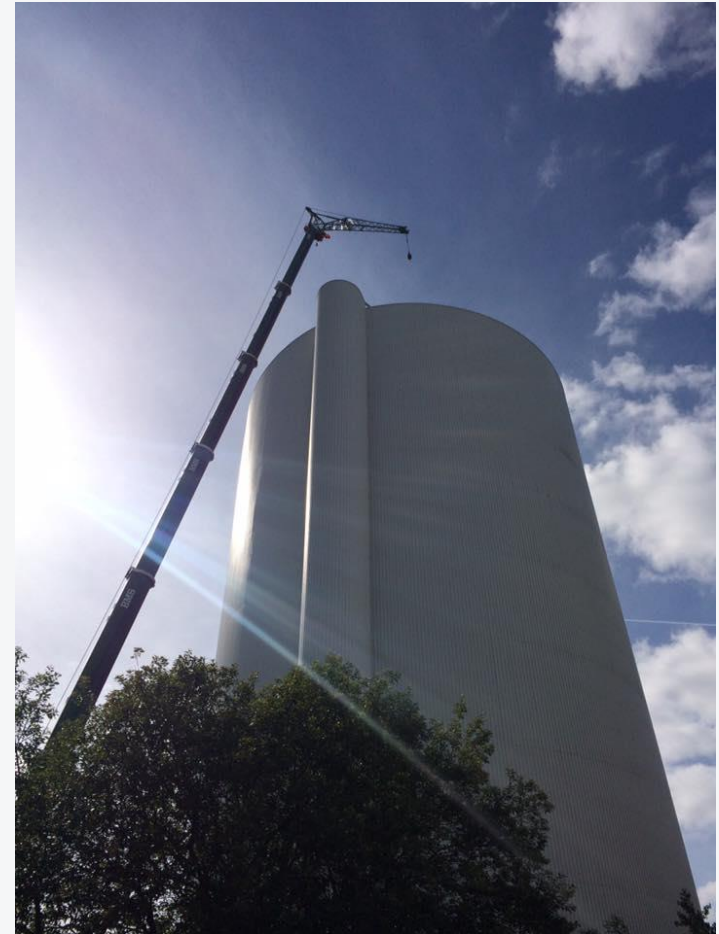
SSV hot water storage tank

- 27.000 m<sup>3</sup> of water
- Operating temperature = 125 °C
- Tank height = 54,80 m
- Min. water level = 45,90 m
- Max. water level = 50,58 m

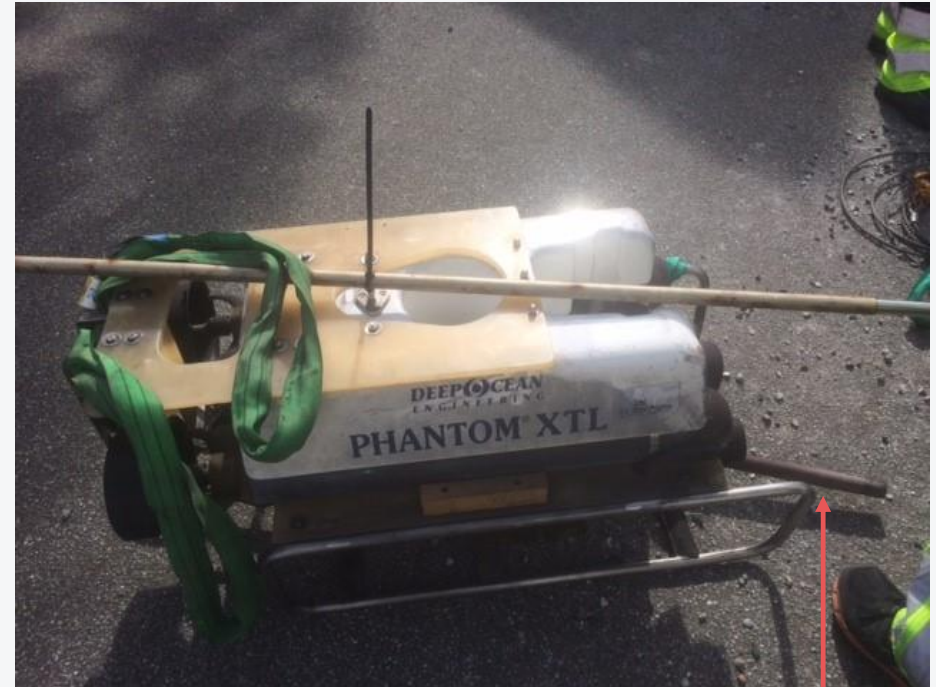
Suction pipe

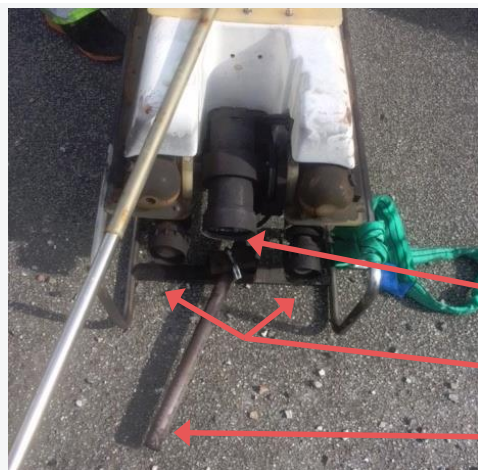
Manhole on top of tank  
Suction hose and power cord  
Camera  
Light  
Suction pipe

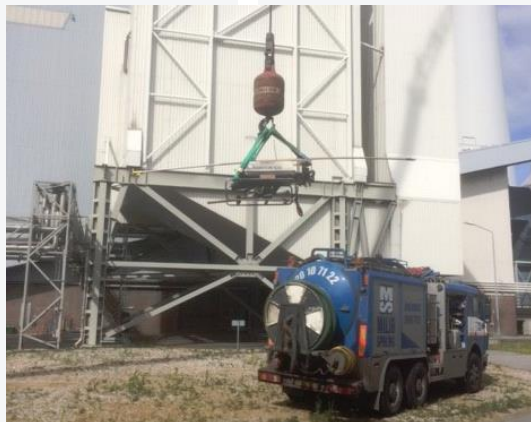
Sludge exhauster for extraction of sediment samples

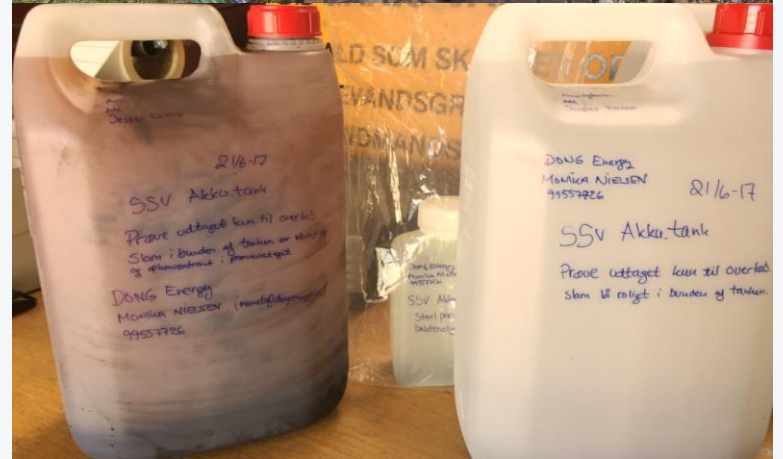
# Sampling of sediment

- 99 % of the sediment consists of Iron
- No sulfate-reducing bacteria
- No indication of microbial induced corrosion

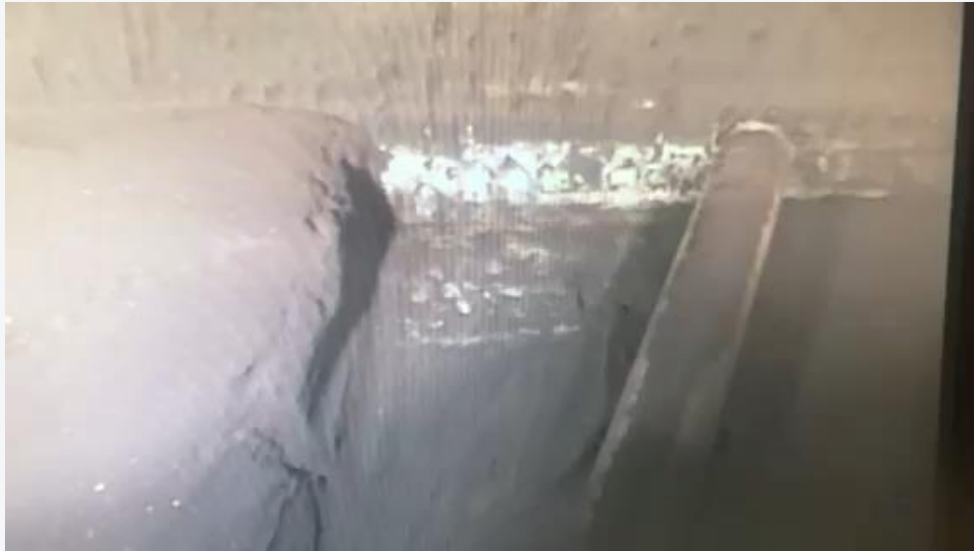
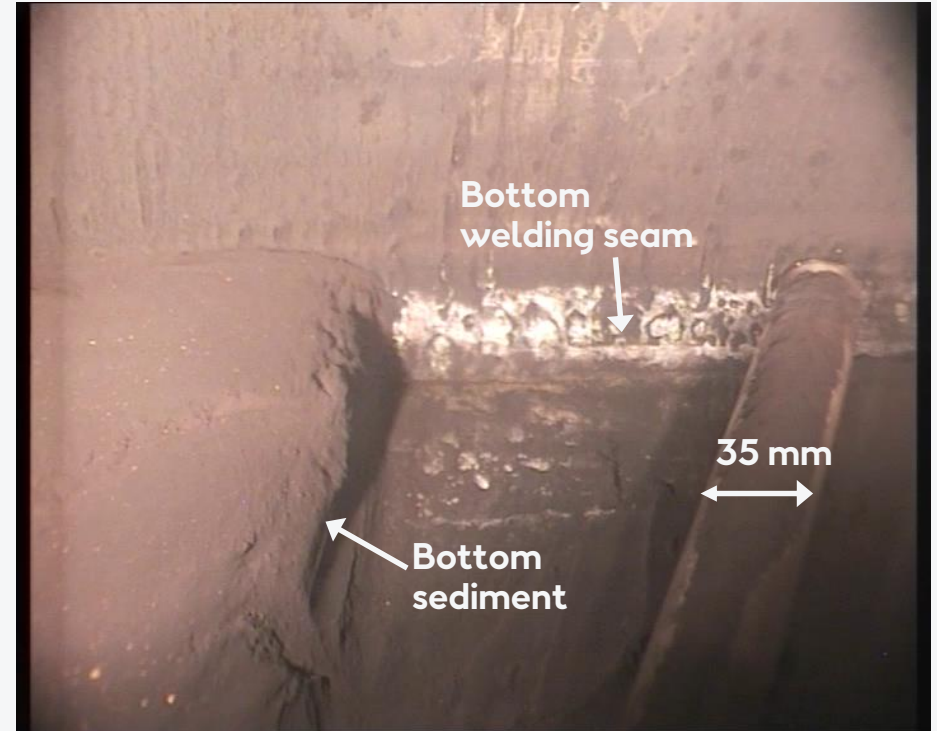
# Inspection of bottom welding seam

Conclusion of the visual inspection of the tank:

- The tank looks as good as new
- No signs of corrosion

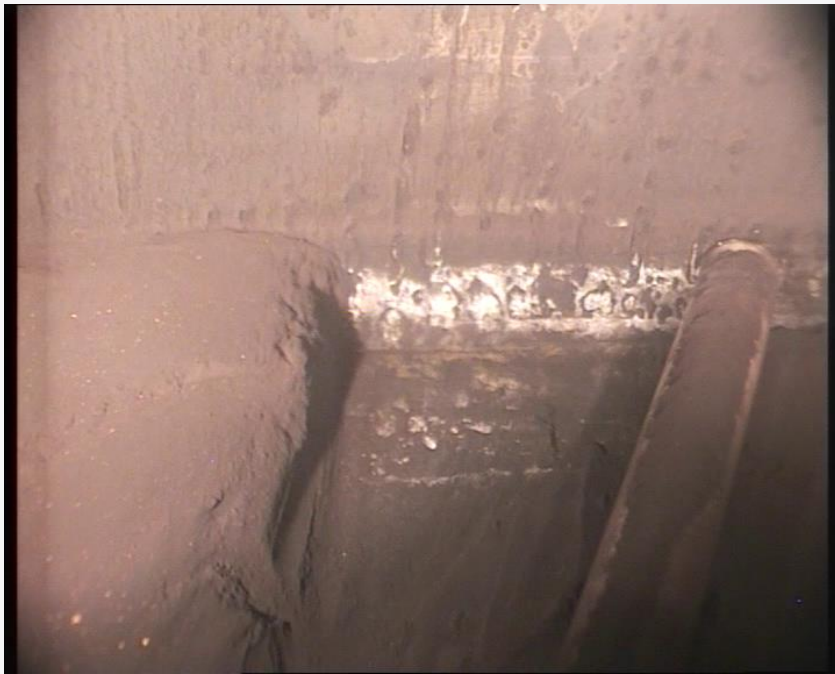
Sediment height in Studstrup storage tank was app. 50-100 mm

Oxygen in makeup water for the district heating system is high!!

High O<sub>2</sub> in makeup water causes high levels of corrosion products in district heating systems!!

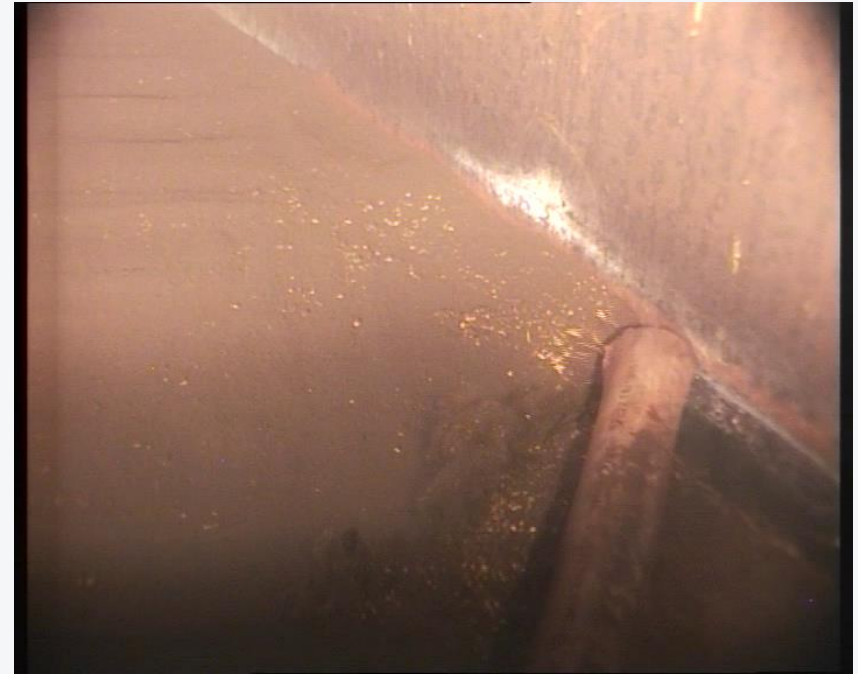
Sediment height in Skærbæk storage tank was app. 10-20 mm

Oxygen in makeup water for the district heating system is low!!

Low O<sub>2</sub> in makeup water keeps low levels of corrosion products in district heating systems!!
